CONSTRUCTION AND PERFORMANCE MONITORING OF VARIOUS ASPHALT MIXES IN ILLINOIS: 2016 INTERIM REPORT

Research Report No. FHWA-ICT-17-003

A report of the findings of
ICT PROJECT R27-161
Construction and Performance Monitoring of Various Asphalt Mixes

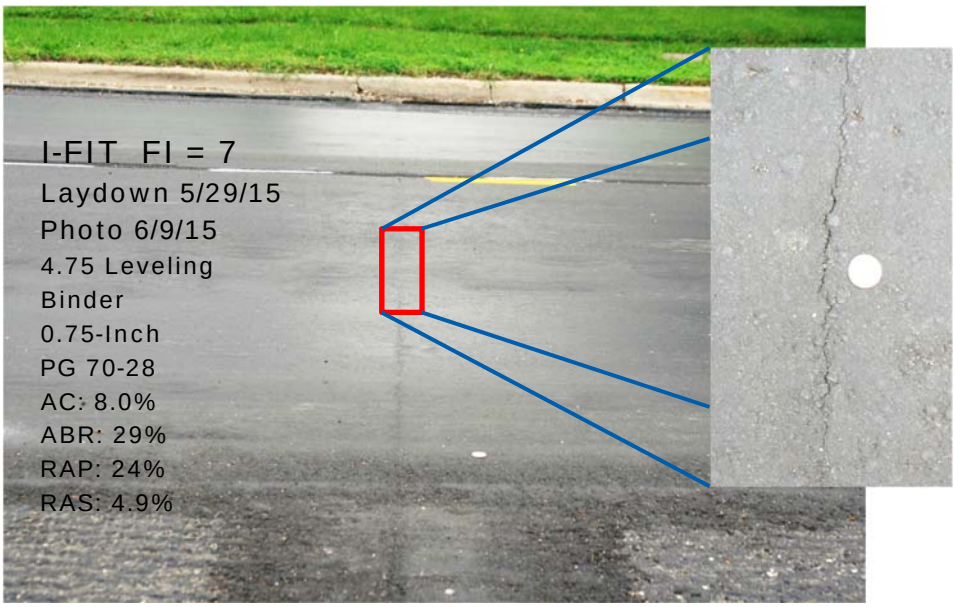
Figure 61. Reflective crack in leveling binder of Washington Street Segment 1

From the limited observations and the data collected to date, it is evident that cross-sections where relatively thin HMA overlays are placed directly upon concrete pavement, there is a high demand for flexibility (high FI values) of the mix to retard reflective cracks as long as possible. Likewise, cross-sections that left 3 or more inches of the existing HMA in place between the concrete pavement and
