EVALUATION OF SENSYS WIRELESS VEHICLE DETECTION SYSTEM: RESULTS FROM ADVERSE WEATHER CONDITIONS

Prepared By
Juan C. Medina
Rahim F. Benekohal
Ali Hajbabaie
University of Illinois at Urbana-Champaign

Research Report ICT-11-81

A report of the findings of
ICT-R27-58
**Evaluation of Wireless Detection Systems at
RR Crossings & Signalized Intersections**

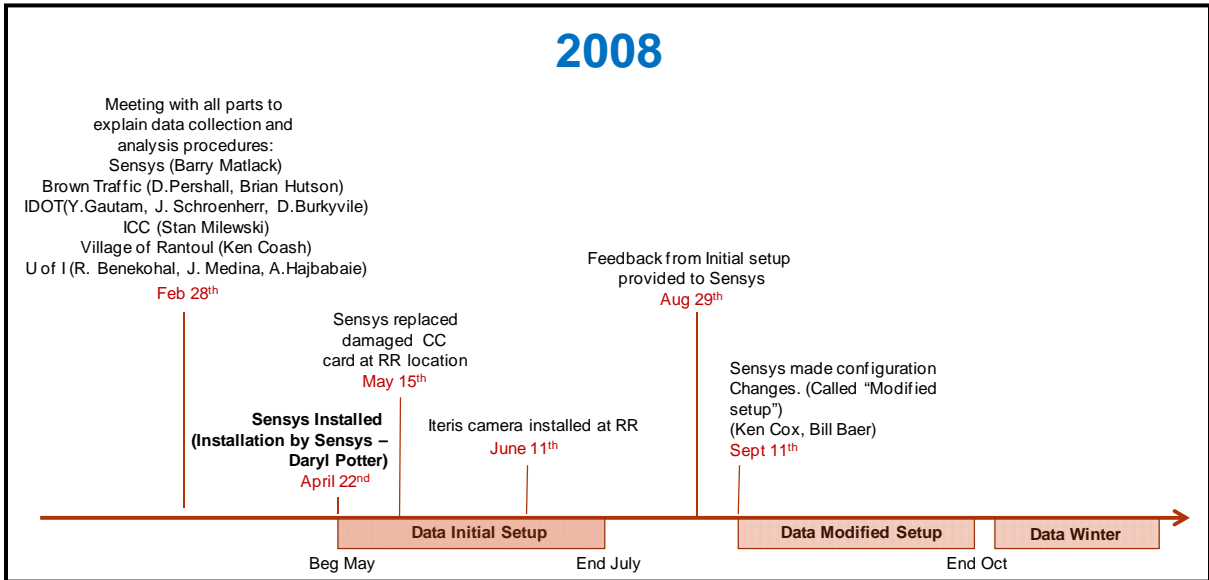
Figure 3. Timeline of events for 2008.

The Sensys system was installed by a Sensys representative at the two selected locations on April 22, 2008. The timeline from the system installation to the end of the data collection for the adverse weather analysis presented in this report is summarized for the years 2008 and 2009 in Figures 3 and 4, respectively.

As mentioned earlier, winter data was collected starting in December 2008 and until February 2009. As it is depicted in Figure 3, a modification of the system configuration was

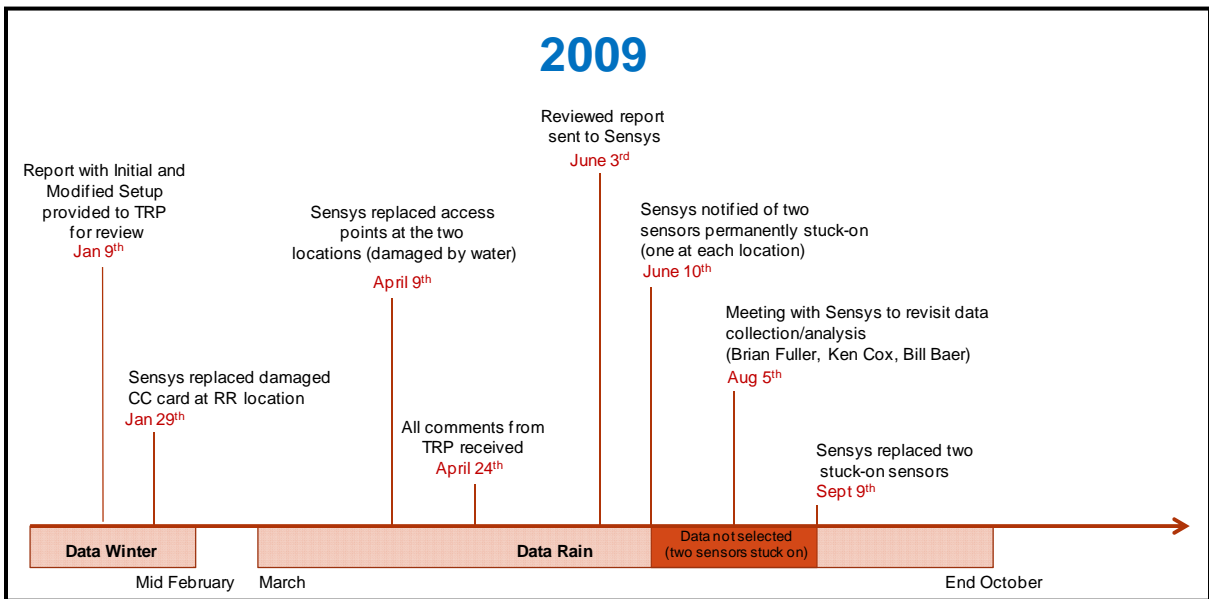
Figure 4. Timeline of events for 2009.
