CIVIL ENGINEERING STUDIES
Illinois Center for Transportation Series No. 13-028
UIIU-ENG-2013-2029
ISSN: 0197-9191

FIELD EVALUATION OF SMART SENSOR VEHICLE DETECTORS AT RAILROAD GRADE CROSSINGS—VOLUME 3: PERFORMANCE IN FAVORABLE WEATHER CONDITIONS

Research Report FHWA-ICT-13-028

October 2013

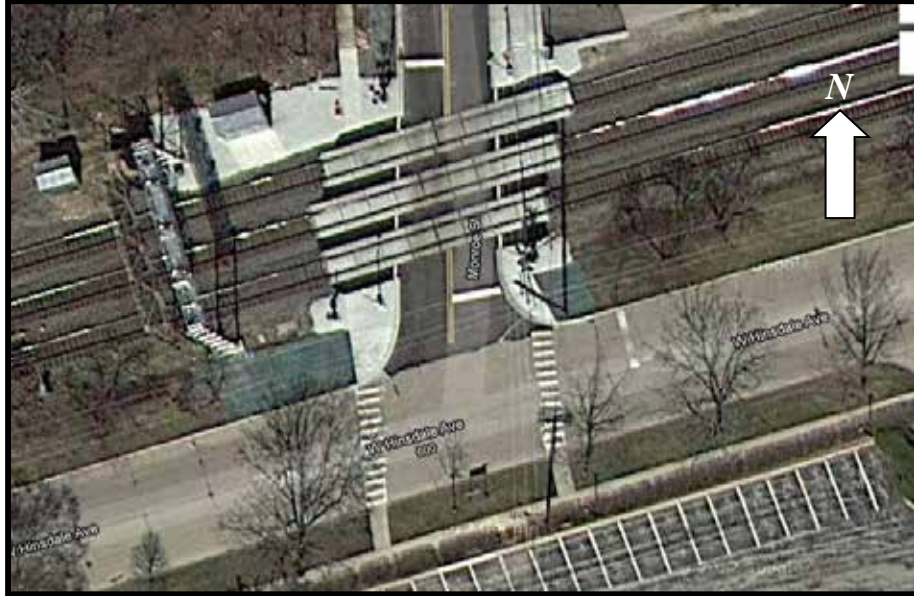
The railroad grade crossing on Monroe Street in Hinsdale, Illinois, near the intersection with Hinsdale Street was selected for this evaluation. At this crossing, three railroad tracks intersect a two-lane, two-way street. The tracks are part of the BNSF network and carry both freight and passenger trains, while the roadway carries a relatively low traffic volume and is located near a T-intersection at the south end of the crossing. A top view of the crossing is shown in Figure 1.

Figure 1. Top view of selected grade crossing on Monroe Street.

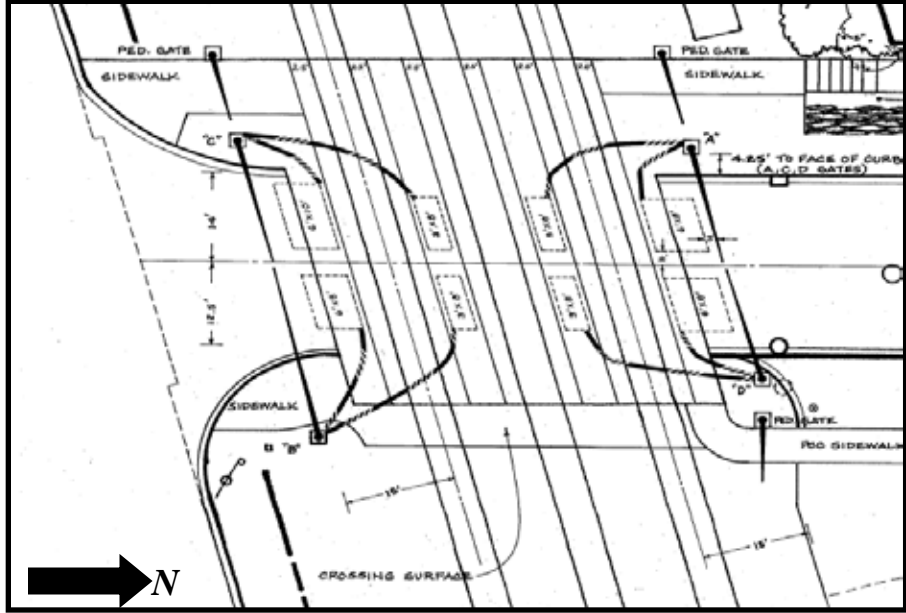
The crossing is equipped with a four-quadrant gate system. The gates are operated by a track circuit to detect train arrivals and by inductive loops embedded in the paved sections to detect vehicles. Along Monroe Street, each lane has four loop detectors: one covering the area before the first track, two for the sections between the tracks, and one for the area beyond the last track. Activations from loops in the same lane are tied together using an “or” operator. Therefore, activations for a given lane indicate whether a vehicle is present in any of the four loops.

A snapshot of the crossing and the location and dimension of loops is shown in Figure 2. This snapshot was taken from drawings by the Village of Hinsdale, Illinois, based on improvements to the gating system performed during fall 2012, prior to the microwave radar testing.

Figure 2. Location and dimension of loop detectors.

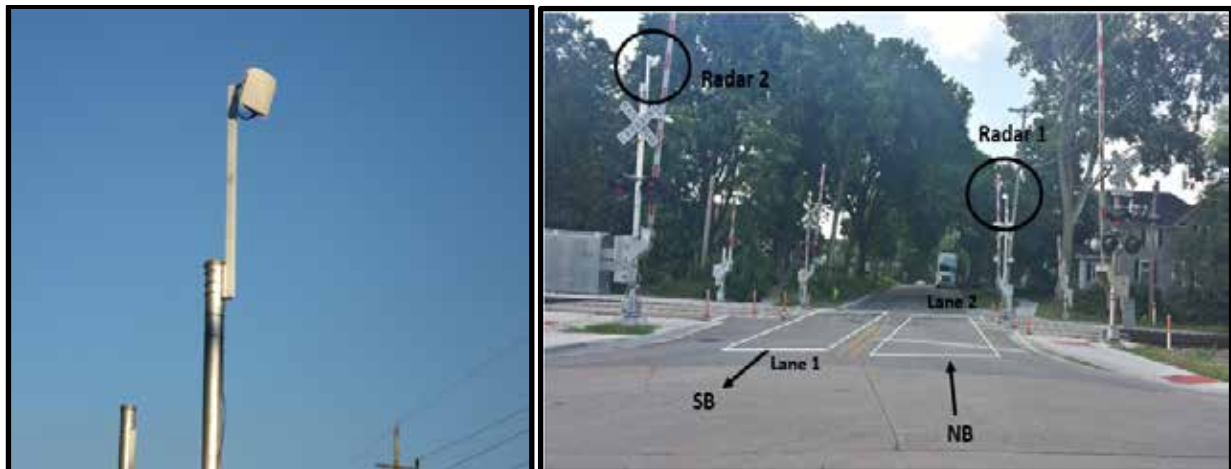
The microwave radar vehicle-detection system had two Wavetronix radars aimed at the crossing from two opposing quadrants: the northeast and the southwest corners of the crossing, as shown in Figure 3. The installed units are modified versions of standard Matrix devices, typically used for stop-bar detection at signalized intersections. In addition to the standard detection capabilities of a Matrix sensor, the units installed at the crossing included the following:

Figure 3. Detail and numbering of microwave radar units and traveled lanes.

The radar system detection was set such that each radar unit generated a single output per lane, covering an area similar to that from the loop detectors. This arrangement resulted in a total of four outputs for the two radar units: Radar1–Lane1, Radar1–Lane2, Radar2–Lane1, and Radar2–Lane2. An illustration of the numbering used for the radar units and the traveled lanes, is shown in Figure 3.

- Rotated southwest-side radar unit (Radar 2) so that the lane positions were optimized within to the detection footprint
- Moved detection zones for Radar 2 to the relocated lane positions
- Tilted Radar 2 upwards to increase marginally the sensor's ability to track vehicles coming down the slope from the north side of the crossing
