EVALUATION OF ADAPTIVE SIGNAL CONTROL TECHNOLOGY—FINAL REPORT

Research Report No. FHWA-ICT-19-006

A report of the findings of
ICT PROJECT R27-127
Safety and Efficiency Benefits of Implementing
Adaptive Signal Control Technology in Illinois

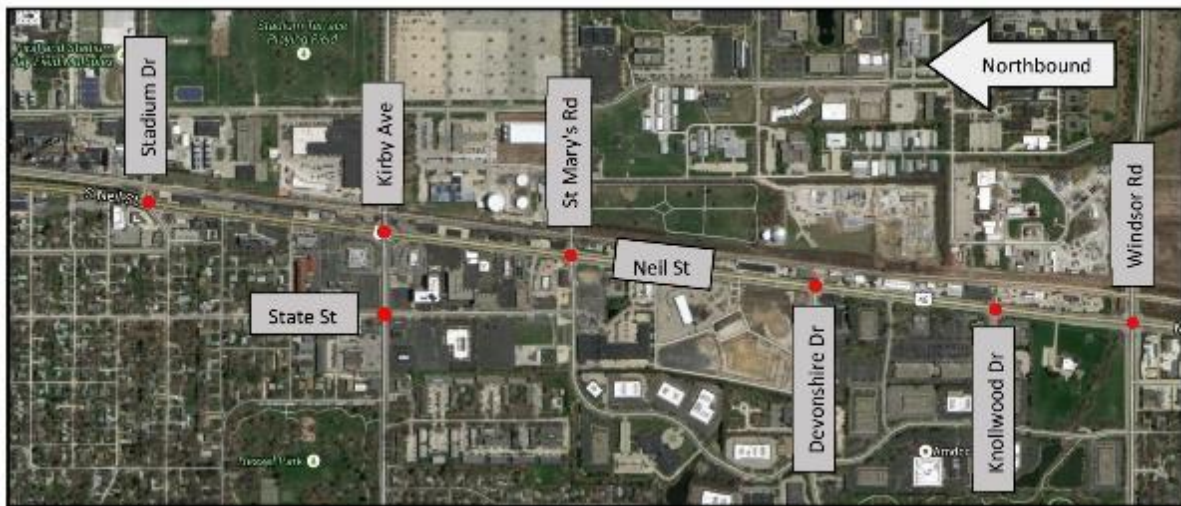
- Neil Street and Stadium Drive
- Neil Street and Kirby Avenue
- Neil Street and St. Mary’s Road
- Neil Street and Devonshire Drive
- Neil Street and Knollwood Drive
- Neil Street and Windsor Road

Figure 1. Deployment location on Neil Street in Champaign, Illinois.

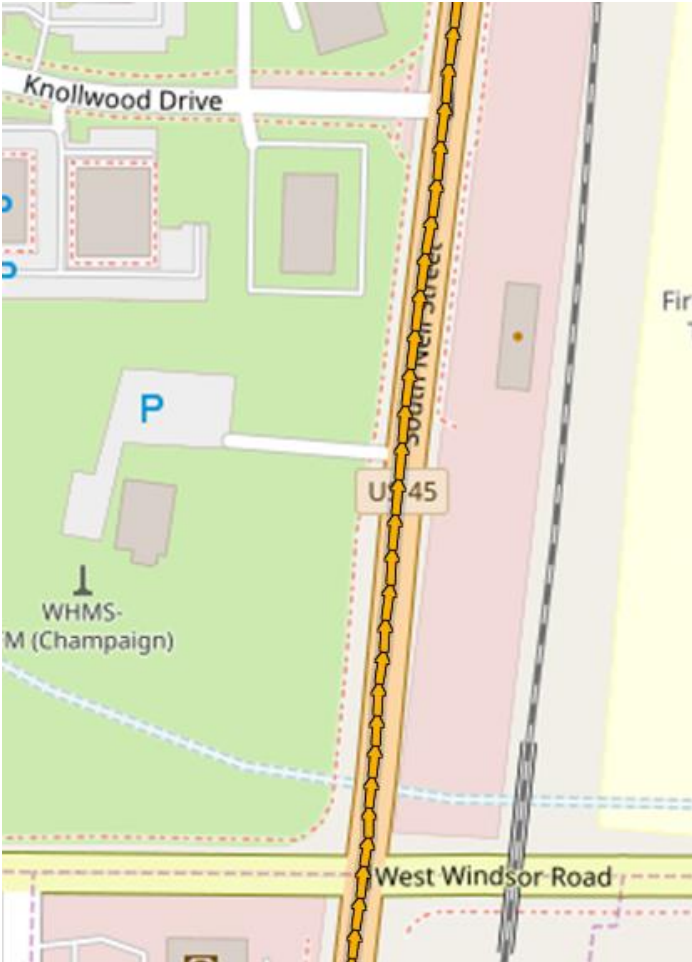
Travel times were determined from GPS data. Specifically, a segment was defined as the distance from the middle of one intersection to the middle of the adjacent downstream intersection. Figure A1 presents an example of travel time between Windsor Road and Knollwood Drive. Each arrow represents the distance that the vehicle traveled in one second, if it was not stopped.

Figure A1. Car trajectory recorded in one-second increments.
